**IMPORTANT INFORMATION FOR OWNERS AND USERS OF ALL CONTAINERING DESIGN
FRAME TANKS MANUFACTURED BY WELFIT ODDY**

APPENDIX A : MOUNT INSPECTION PROCEDURE

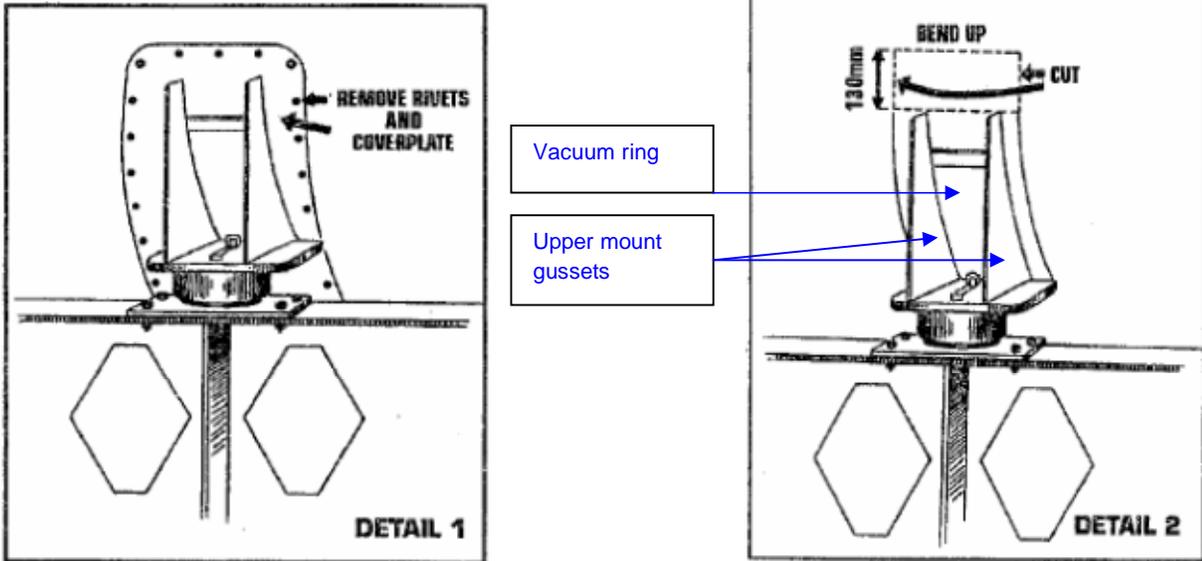
A) UPPER MOUNTS : On all 4 tank mounts, remove the upper cladding cover by drilling out the pop rivets. Cut the aluminium cladding with 2 parallel cuts approx 130 mm from the upper edge of the aperture – this will enable the cladding to be rolled / bent upwards to gain access for inspection. Remove any insulation in the area, and clean by means of wire brush

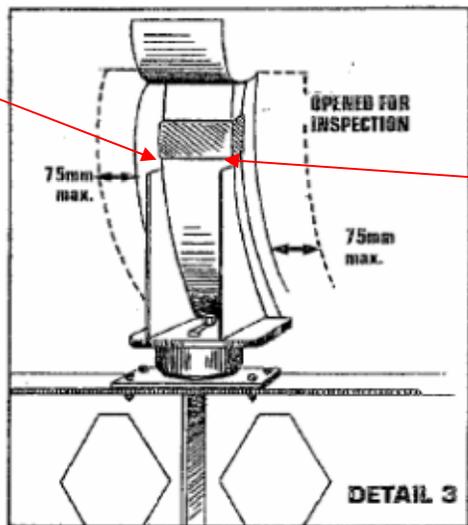
Upper mount inspection point : Inspect for cracks on the front and side wall of the vacuum ring at the top junction of the upper mount gusset and the vacuum ring, and on the tank vessel adjacent to this area

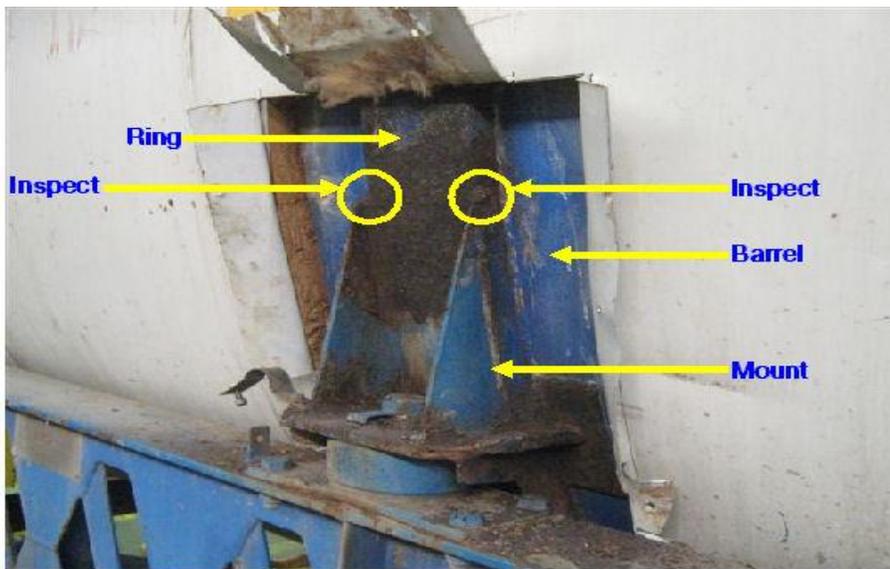
Upper mount inspection point : Inspect for cracks on the front and side wall of the vacuum ring at the top junction of the upper mount gusset and the vacuum ring, and on the tank vessel adjacent to this area

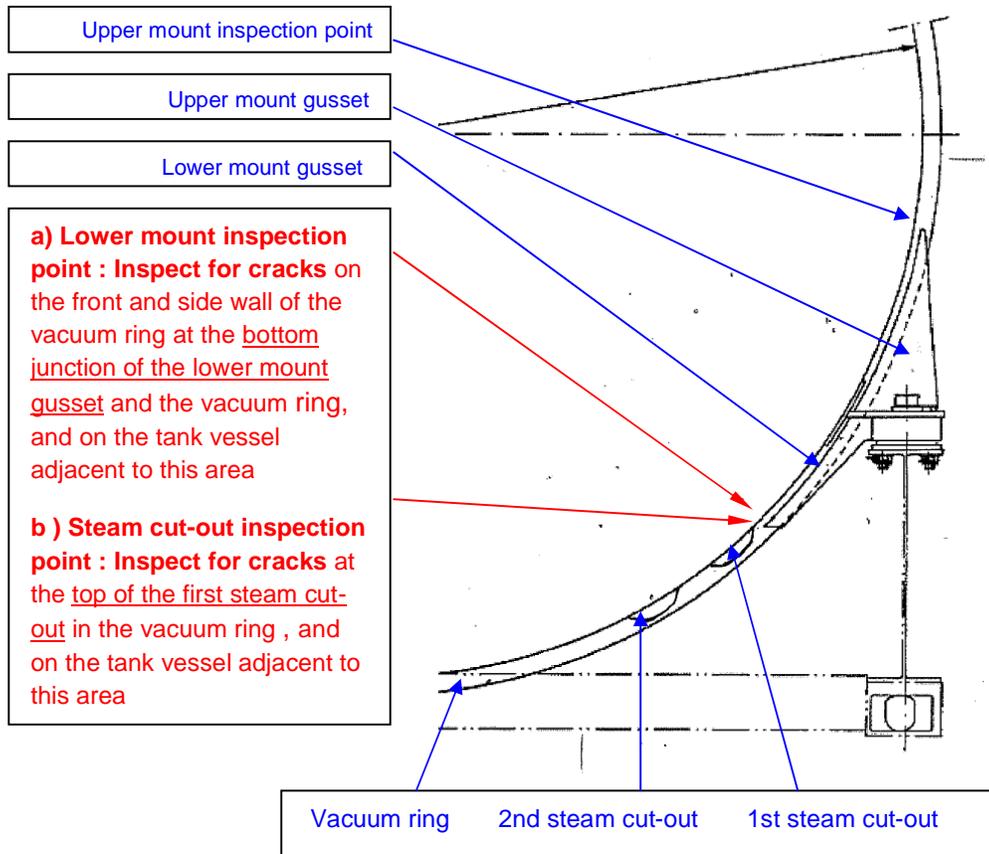
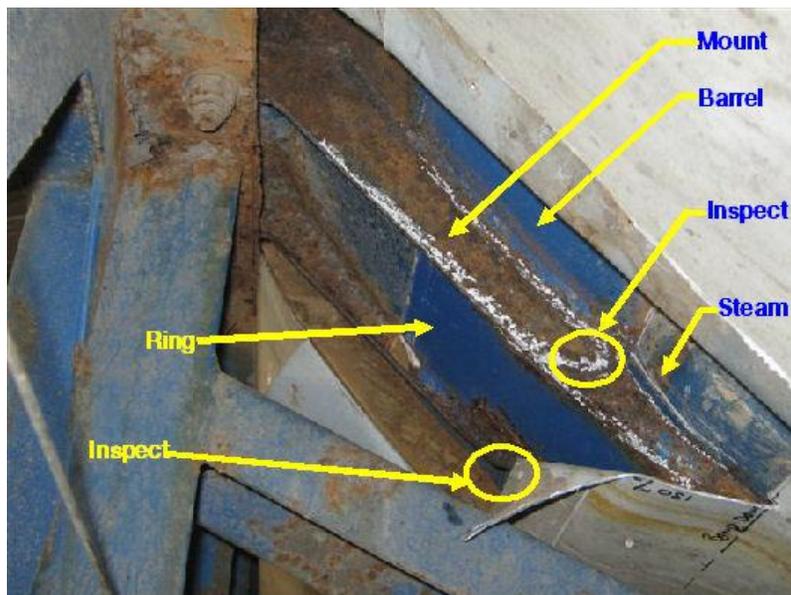
B) LOWER MOUNTS and C) TOP OF THE FIRST STEAM CUT-OUT : The inspection procedure for these areas is a mirror image of that for each of the top mounts.

Remove the cladding panel and insulation , and clean by means of wire brush :

After inspection and any repairs, clean / wire brush the area in preparation for painting. Apply primer using a rust inhibiting primer such as a zinc rich epoxy. Apply top coat in matching colour using an acrylic paint. Reinsulate using mineral wool. Roll down cladding and rivet the cladding cover plates back into position. Re-seal all joints
